The Challenge:

The OxyTek Solution:

OxyTek™ Case Study 1000155: Industrial Property, Burlington, Ontario

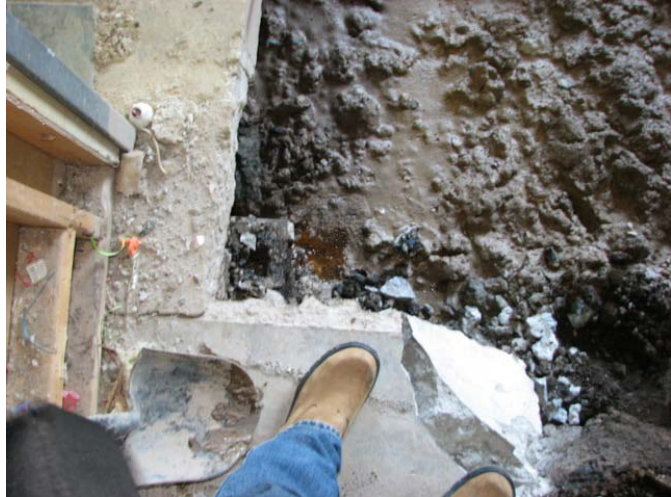
Free phase product was present below building

- Injection wells were installed in the area of impairment, both inside the building and in the parking lot area.
- OxyTek-L™ and OxyTek-PS™ were injection to reduce VOC levels to Regulatory criteria and project closure was achieved to meet stakeholders' real estate deadlines.

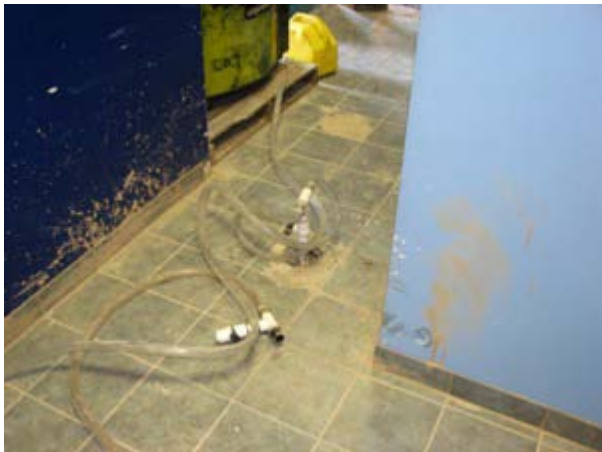
OxyTek-L™ was injected into wells in the office area of the building

Sixty injection wells were installed in the area of impairment. Multiple injections of OxyTek-L™ and OxyTek-S™ were required due to the dense clay soils on-site.
