**The Challenge:**

**The OxyTek Solution:**

## OxyTek™ Case Study 10010: Dairy Transformation Plant, Quebec

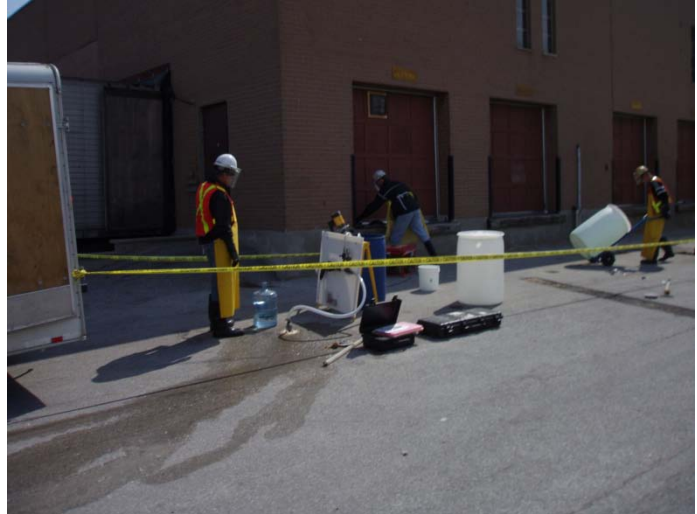
OxyTek-S™ being injected in wells installed outdoors.

- Thirty injection wells were installed to 7 metres inside the building and in the former tank farm area.
- OxyTek-S™ was injected into the wells, to reduce PHC concentrations to meet Regulatory criteria. Ministry of the Environment (MENV) Generic C criteria objectives were achieved.

A series of thirty injected wells were installed to 7 m bgl. Due to the soil conditions and to prevent migration into the nearby river, the OxyTek-S™ was injected as a slurry into the wells.

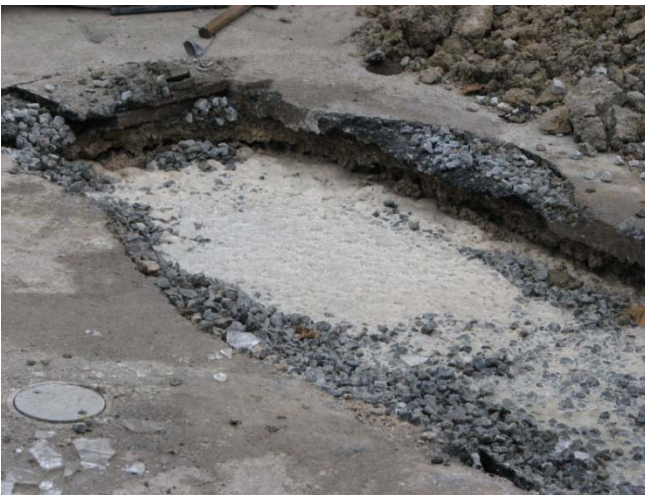
Chemical reaction of OxyTek-S™ in former tank farm area
