**The Challenge:**

**OxyTek™ Case Study 100033:  
Former Industrial Manufacturing Site, Waterloo, Ontario**

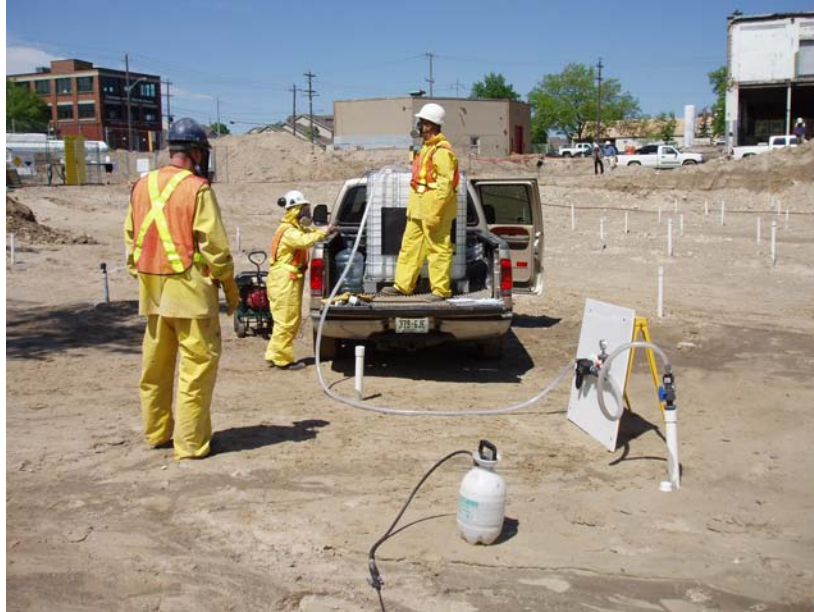
Injecting OxyTek-L™ into injection wells

- Eighty nine injection wells were installed in the area of impairment. OxyTek-L™ was injected in the wells to reduce VOC concentrations to meet Regulatory criteria in the soils and groundwater.
- OxyTek-L™ reduced VOC levels to Regulatory criteria in three injection events and project closure was achieved.

Eighty nine injection wells were installed in the area of impairment. Multiple injections of OxyTek-L™ were required due to the dense silty clay soils on-site.

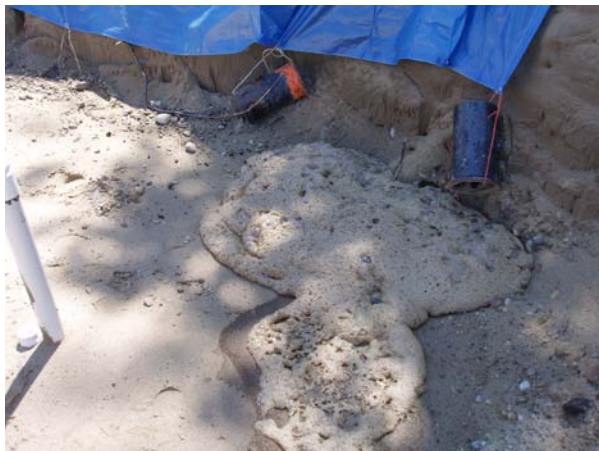
OxyTek-L™ at work, with the oxidation process generating oxygen in the water
