**OxyTek™ Case Study 100039:
Former Blueprinting Facility, Scarborough, Ontario**

Groundwater Concentrations Pre-Treatment and Post-Treatment using OxyTek-L™

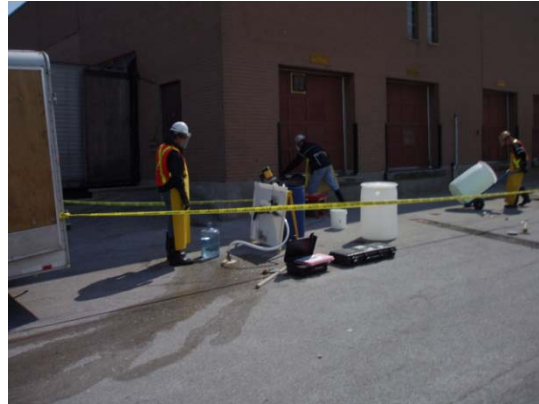
Injecting OxyTek-L™ into injection wells around building

- The existing wells and thirty additional injection wells were installed in the area of impairment. OxyTek-L™ was injected into the wells to reduce VOC concentrations to meet Regulatory criteria.
- OxyTek-L™ reduced VOC levels to meet Regulatory criteria in three injection events. Closure of the project was achieved to meet the stakeholders' real estate closing.

Thirty injection wells were installed in the area of impairment. OxyTek-L™ was injected into the wells over three treatment intervals. The treatment was allowed to stabilize for 10 days prior to sampling.

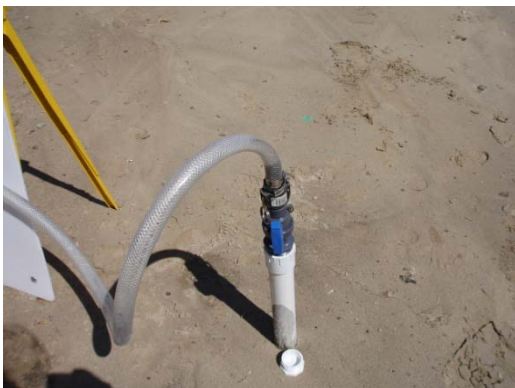
Injection well with OxyTek-L™ being loaded
